No way to enable SSH access to your new router?

The vendor might have
something to hide

Stanislav Dashevskiy
Francesco La Spina
hack.lu@2025

Today's target: TP-Link ER605 v2

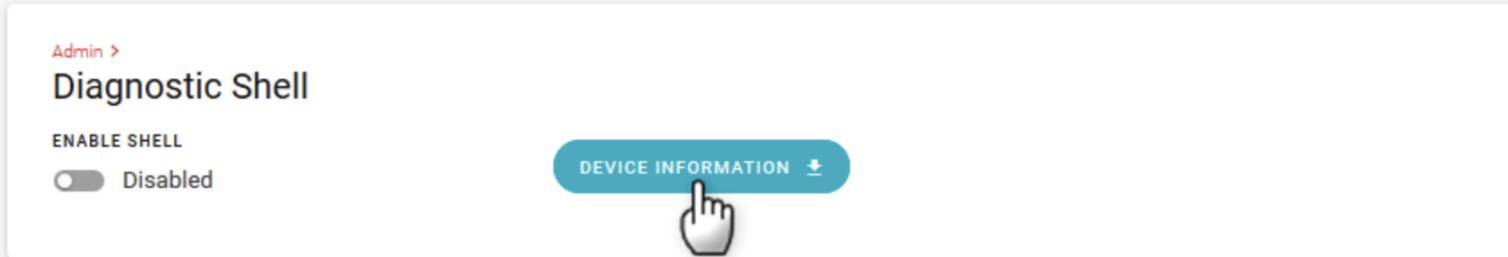
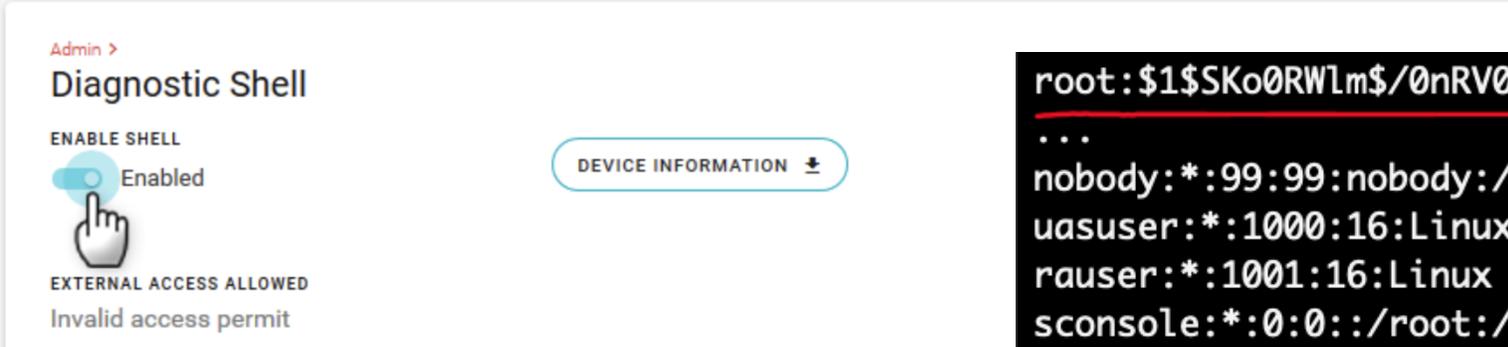
Read the docs: Sierra Wireless

When remote help is required, enabling the Diagnostic Shell allows Sierra Wireless support to access your device via SSH.

1. After being directed by Sierra Wireless support, click DEVICE INFORMATION.

2. Save the request.txt file.
3. Send the request file to Sierra Wireless support, who will generate an access permit file for you to upload to the device.
4. Enable the Diagnostic Shell.

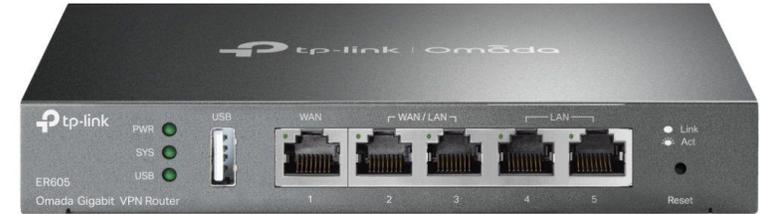
- Based on the MediaTek MT7621 SoC with 5 10/100/1000 Mbps Ethernet ports
- Used to “support” OpenWRT
 - OpenWrt can be installed by first getting a root shell on the device. The root password is derived from the device MAC and the admin user ID. The whole process is [described in this GitHub repository](#)
 - https://openwrt.org/toh/tp-link/er605_v2
 - https://github.com/chill1Penguin/er605v2_openwrt_install/

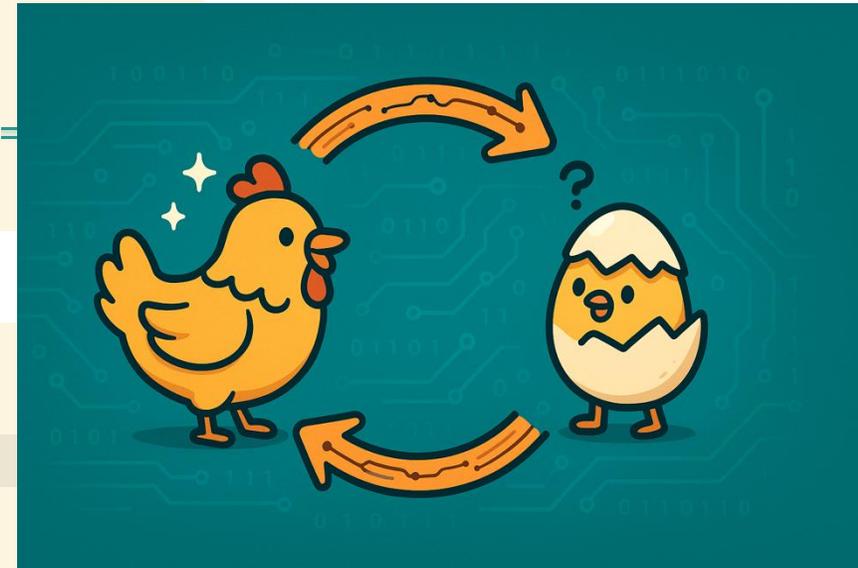
TP-Link: CVE-2025-7851

```
if ( access("/usr/sbin/image_type_debug", 0) ) {  
    // Send a challenge and verify the signature (requires the private key).  
    // If the signature is correct, grant the root shell.  
}  
else {  
    // Ask for a password derived from the LAN mac address.  
    // If the password is correct, grant the root shell.  
}  
//...
```

Getting root this way requires having root or obtaining that private key.
